# **Review of Incident at KPD Aarhus Terminal 17<sup>th</sup> August 2008**

KPNWE / TIEMS Safety Workshop, Luxembourg  
26<sup>th</sup> and 27<sup>th</sup> September 2008

John Briggs KPI Regional SHE Manager

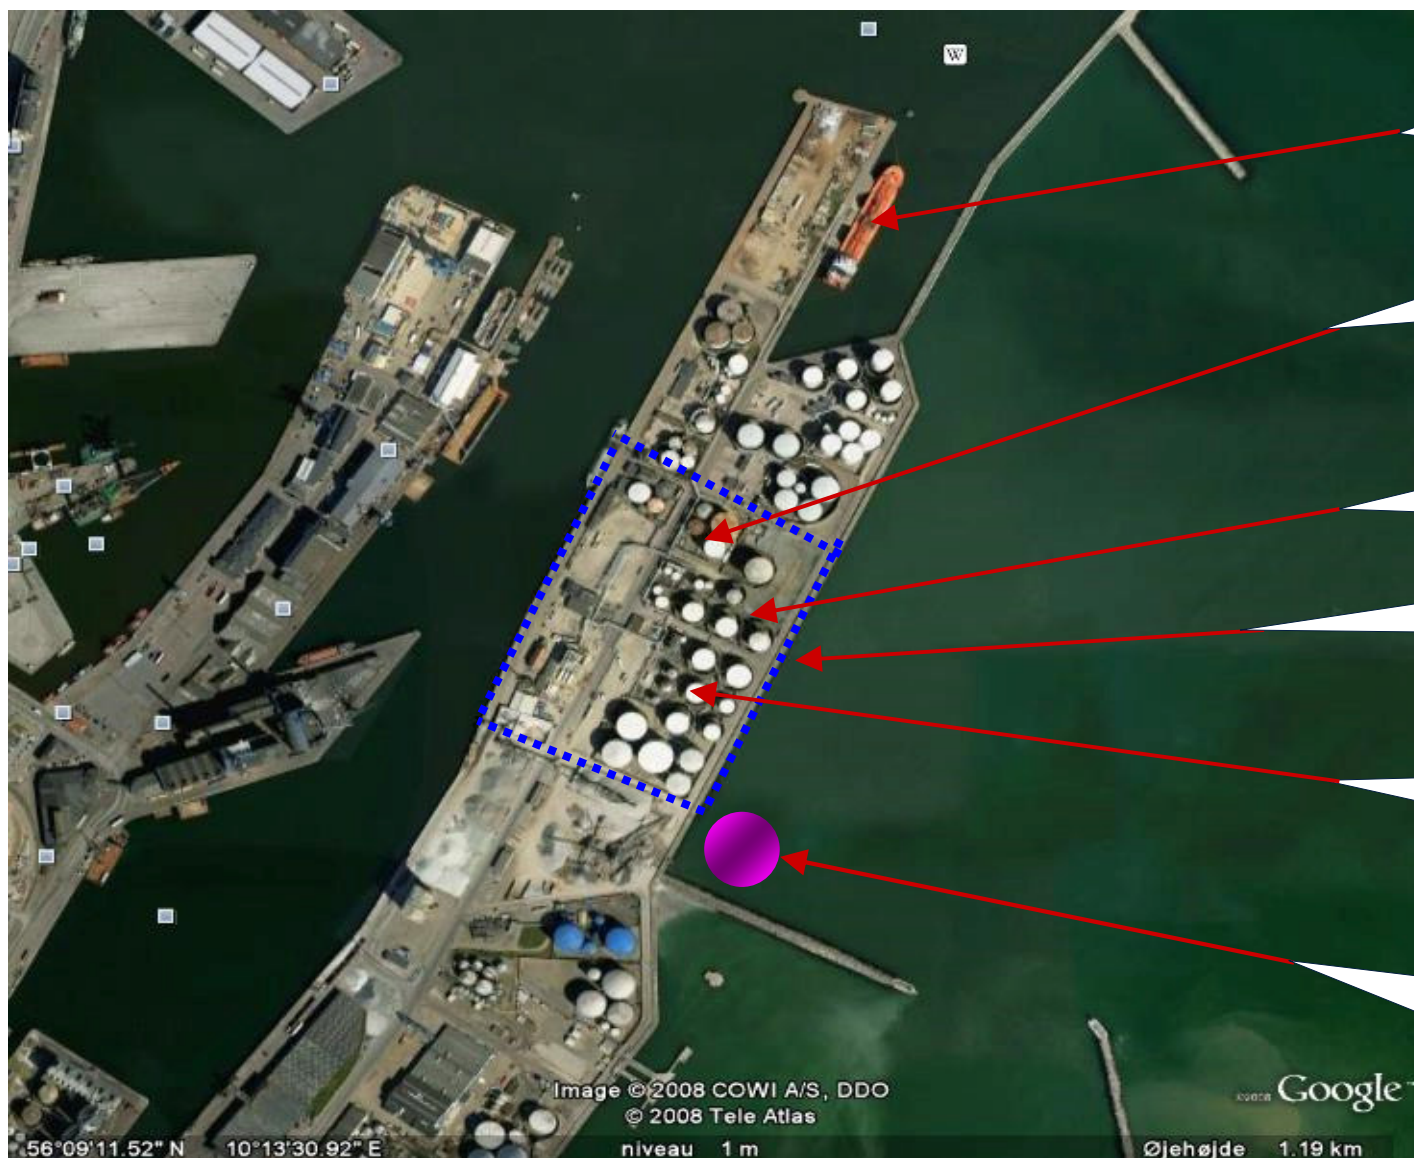
Location of incident – through open valve

Outflow from rain water sewer system

Contamination "trapped" by wind and waves for "easy" removal

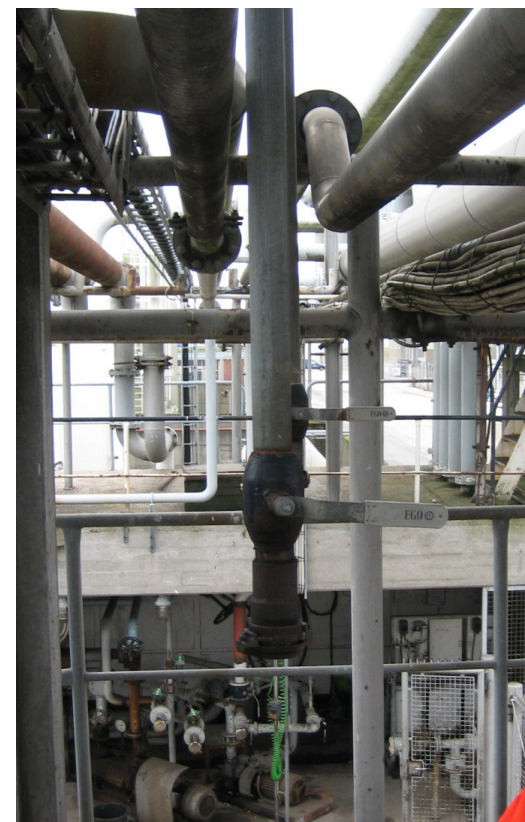
- One gasoline pipeline from the jetty feeds into two separate terminals (series one terminal and series two terminal), via a pipeline junction.
- It is the responsibility of Operator 2 to prepare the pipeline junction for the discharge. This process includes blanking the line to series one terminal at the junction, emptying approximately 100 litres of product from a drain trap, then opening the pipeline to series two terminal at the junction.

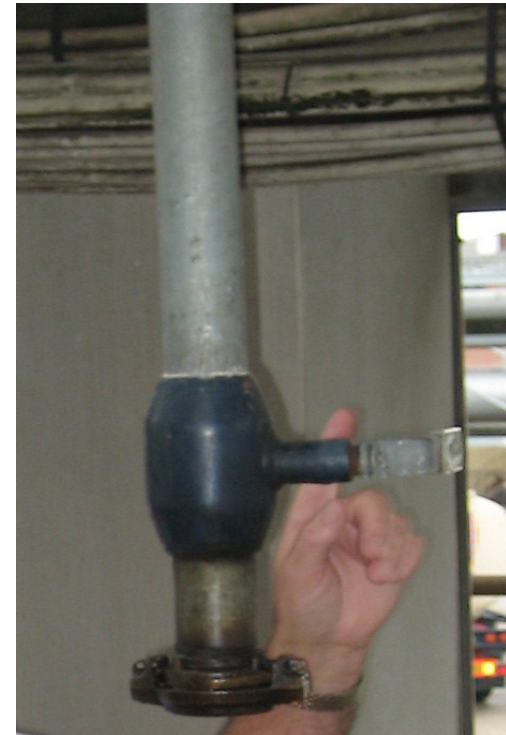
- Emptying the drain trap is carried out by manually opening a valve, waiting approximately 30 seconds for the trap to empty, then manually closing the drain valve, before carrying out further duties.
- On the day of the incident Operator 2 opened the valve, then proceeded to carry out other duties, leaving the valve in the open position.

- Manually operated valves
- Comprehensive high level process instructions in place but no low level operator work Instructions
- No low level operator checklists
- Lack of ongoing operational refresher training
- Engineering of pipeline junction (drain product)
- Terminal operator negligence

- Install spring operated drain valves
- Review high level process instructions (introduce low level operator checklists)
- Develop low level operator work instructions
- Introduce ongoing operational refresher training
- Use external expertise to carry out a Terminal Risk Assessment which assesses all the processes
  - Risk assessment will include a review of the engineering of the pipeline junction
- Install local vapour detection equipment
- Communication of incident to all stakeholders

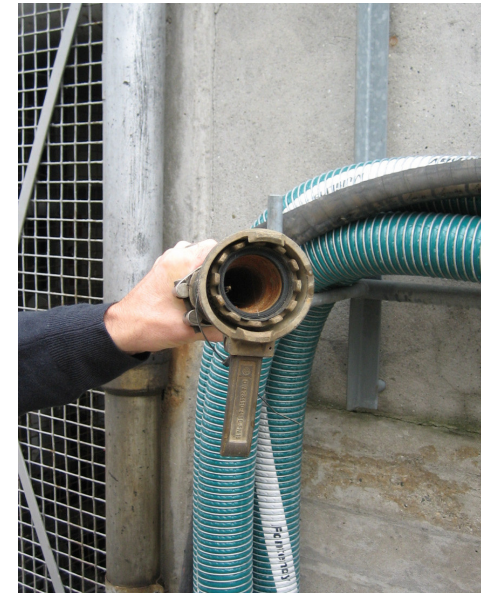
- Gasolene flowed down the pipeline into the tank, but a small amount of gasoline also flowed through the open drain valve, down a drain hose, into a 1000 litre drain tank.
- The 1000 litre drain tank overflowed and the gasolene entered the surface water drain system and was discharged into the harbour basin.

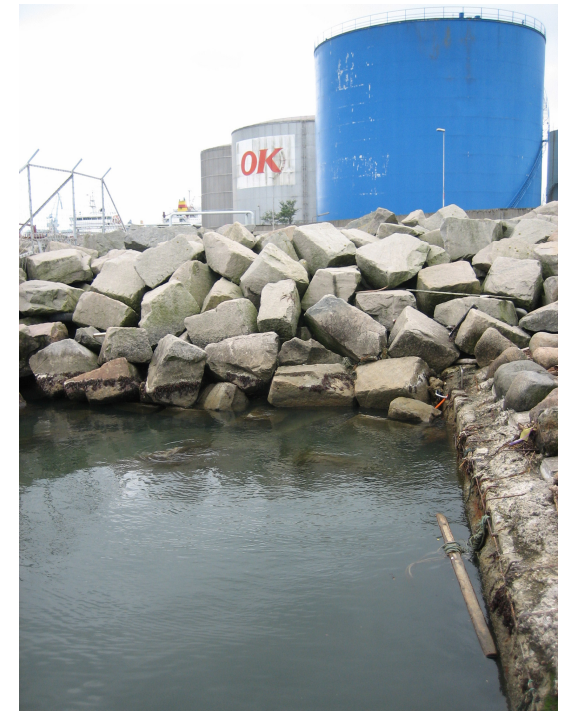
- 23,000 litres of gasoline was spilled into the harbour basin.
- After 1 hour the vapour from the gasoline was detected and the source of the vapour found to be the open drain valve.
- Emergency procedures were put in place until the arrival of local authorities/fire service, who then took charge of the situation. Due to the wind conditions, the contaminated seawater collected in a local area and it was contained by the authorities.
