HURRICANE ANDREW AND EMERGENCY PREPAREDNESS FOR ELECTRIC POWER RESTORATION

Kostas G. Zografos
National Technical University of Athens

Manny Miranda
Florida Power and Light

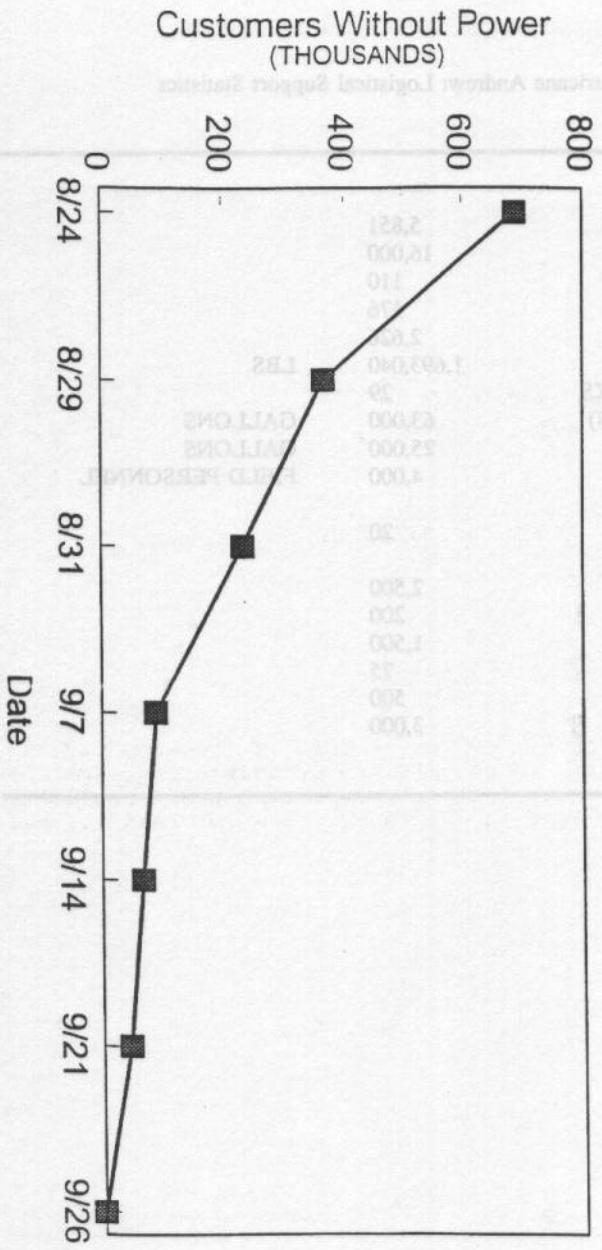
Figure 1: Progress of the Service Restoration Process

Dade County Hurricane Andrew

The substantial differences observed on the level of destruction between the northern and southern part of Dade County were rightly reflected on the progress of the service restoration process between the two parts of the County. Thus, the service restoration mechanism of the northern part of the county was able to restore services, according to the pre-determined storm plan, in a fast manner. As it can be seen in figure 1 the service restoration process for the northern part of the county was concluded within 14 days, while the service restoration process for the southern part of the county required almost one month.
