NATURAL SLOPE INSTABILITY MEASURES OF ROADS IN HILL COUNTRY, SRI LANKA

Eng. A A Virajh Dias
Laboratory, EPC Division, Central Engineering Consultancy Bureau (CECB),
No. 11, Jawatta Road, Colombo 5, Sri Lanka.
Email : virajh@mailcity.com
Eng. Upul Goonasekara, Deputy General Manager, WR Unit, CECB
Eng. Nihal Rupasinghe, Additional General Manager, EPC Division, CECB

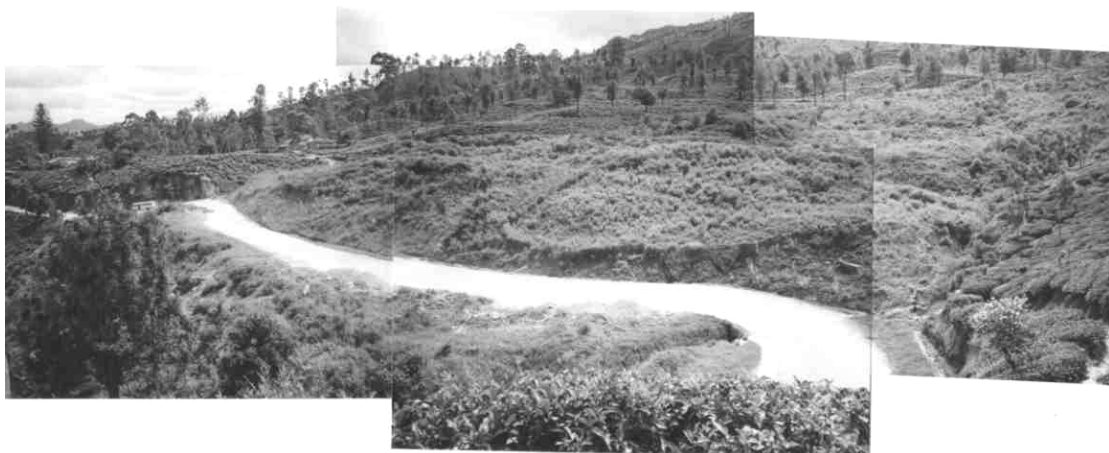
Fig .2: The most significant effect of landslides is the disruption of transportation and the destruction of private and public property. Some work has been done to prevent developments on top of or below slopes subject to sliding. However, the slide reactivate during last 15 year period, Kahagolla, Sri Lanka.

In recent memory in Sri Lanka, peaks of landslide activity had occurred in January, 1986 and then again in May – June 1989, October 1996(Fig.2) and most recently in November 1998 (Fig.1). All above situations, landslides affecting the national highway network of the hill country.

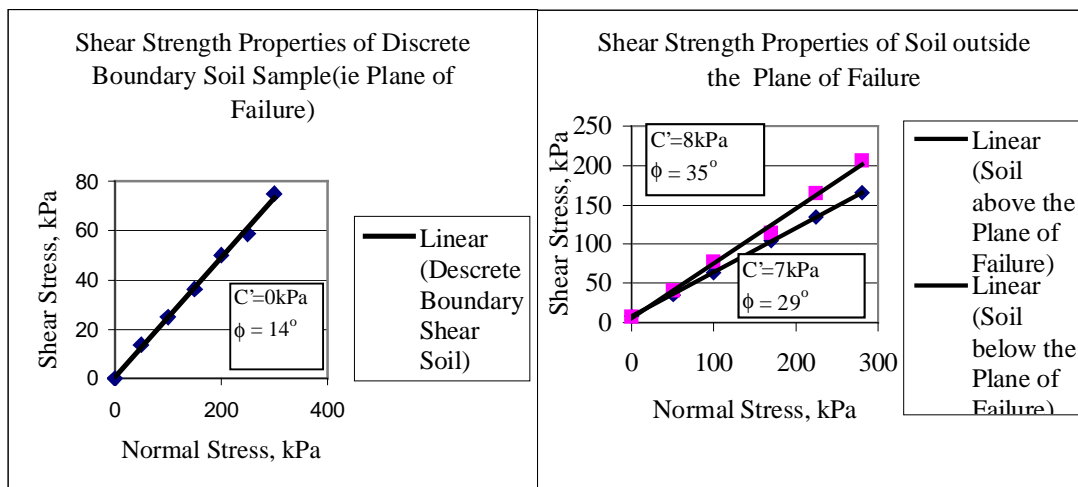
Fig 4: Average shear strength parameters on Discrete Boundary Shear samples

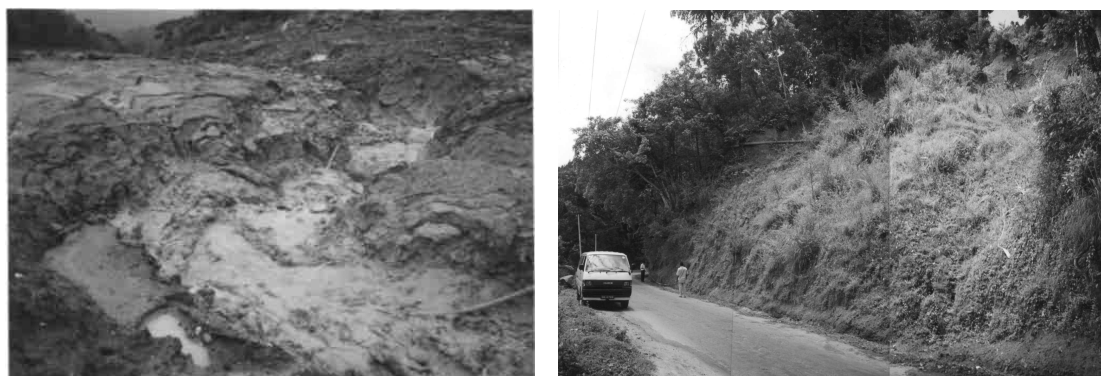
Fig.5 : Most common failure mechanisms associated with the hill country, Sri Lanka

Primary observations(Fig.5) are readily available through the number of earth cuts at the road trace at hilly area. The second and the major instability problem which encountered in the road trace is number of shallow to deep landslides. Thirdly, several observations on the ground confirm that the landslide material was in free fall during prolong period of rain and that may rocks bounced on impact.

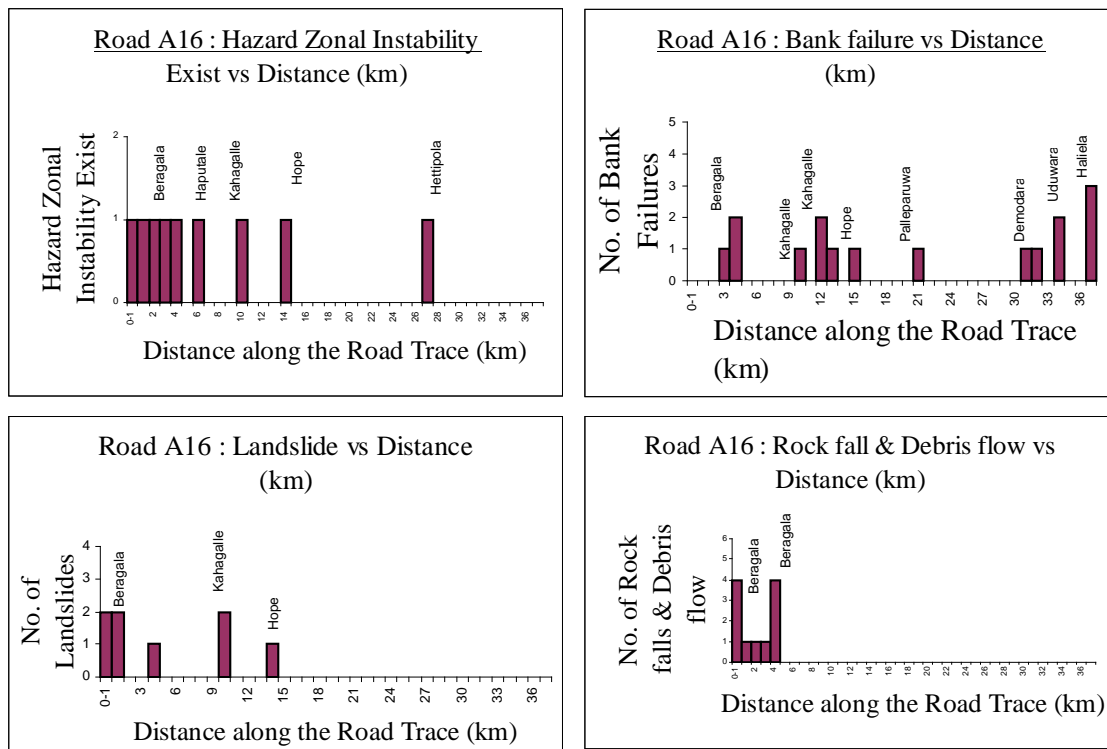
Fig. 6: Potential instability measures along the A16 road; Beragala – Haliela, Sri Lanka for an emergency planning against Landslides.

The A16 road at Beragala which is located 180km away from Colombo, are in landslide proven areas. In addition, A4 road; Colombo-Ratnapura-Wellawaya-Baticalloa; CRWB road between Balangoda and Wellawaya, and the A5 road between Gampola and Nuwara Eliya is located in landslides and rockslide proven areas respectively. These trunk roads are extremely significant routes, which connects Colombo with the Central Province, Eastern Province, Sabaragamuwa Province and Uva Province.

Landslide hazard has been determined with a high degree of reliability for only a few locations. When a potential hazard is present in the study area, the first step is to undertake a brief survey to establish whether landslides have occurred in recent times as in Fig 6. Roads, railroads, and river banks are good sites for seeking signs of past landslide occurrence. Then landslide hazard map with the integrated of direct field evidences as above will contribute to some accuracy for emergency planning scheme of a road project. There are two situations when such intergraded landslide map may prove beneficial, both of which are related to mitigating the potential effects of landslides. In one case, it is conceivable that if areas identified with a moderate landslide hazard are targeted for development, greater detail of those areas is needed to ensure the project design compensates for this greater hazard potential. For example, moderate or higher hazard areas may not be entirely avoidable along any proposed road trace in hill country. In another case, existing infrastructure or communities may be located in previously unidentified high hazard zones. These

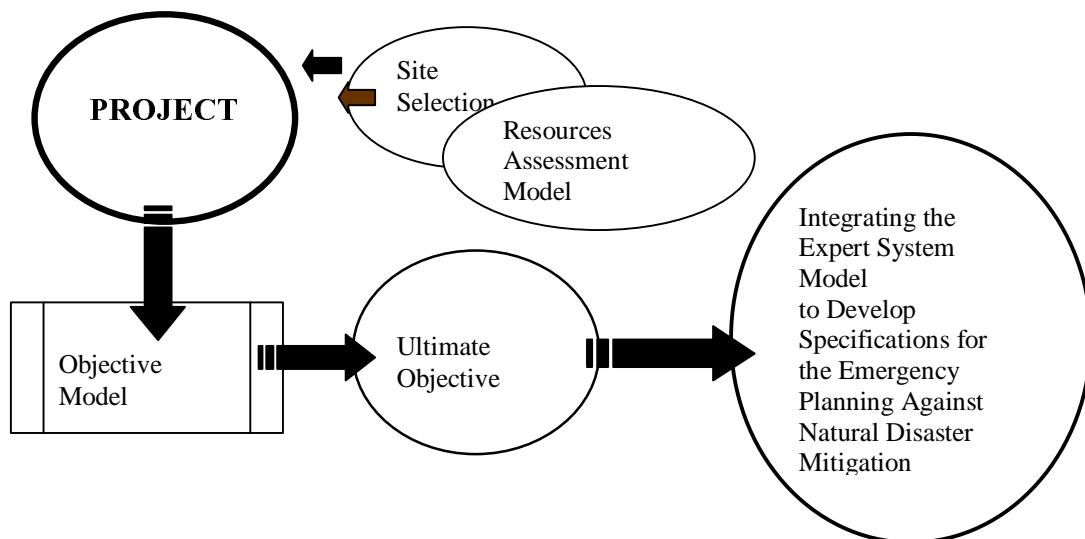
Fig. 7 : Basic model approach for Knowledge Base System Analysis

Today, various applications of knowledge base expert systems has been increasing significantly as a research on application tool for engineering analysis, design and management. Classification problems commonly encounter in hazard assessment and planning for emergency against natural disaster including selection, diagnostic, evaluation, interpretation, prediction, monitoring and control. All these problems choosing one or more " solutions" from a predicted and finite set of possible solution for the problem - even continuous evaluation involves choosing a part or interval on a defined scale for each dimension of interest. Therefore, this type of system model will help planner in diagnosing the type of problem. This will face with evaluation of hazard risk on hill slope area and predicting failures accurately to some extent with an appropriate site conditions. The author pin point in some basic development approaches what is useful in KBEs for the prediction and performance in Hazard Integration for Emergency Planning model (Fig.7).
