GUJARAT, INDIA AND WASHINGTON STATE, USA: A CONTRAST IN EARTHQUAKE PREPAREDNESS

Michael A. Trevits, PG, MBA¹

9th Annual Conference Proceedings

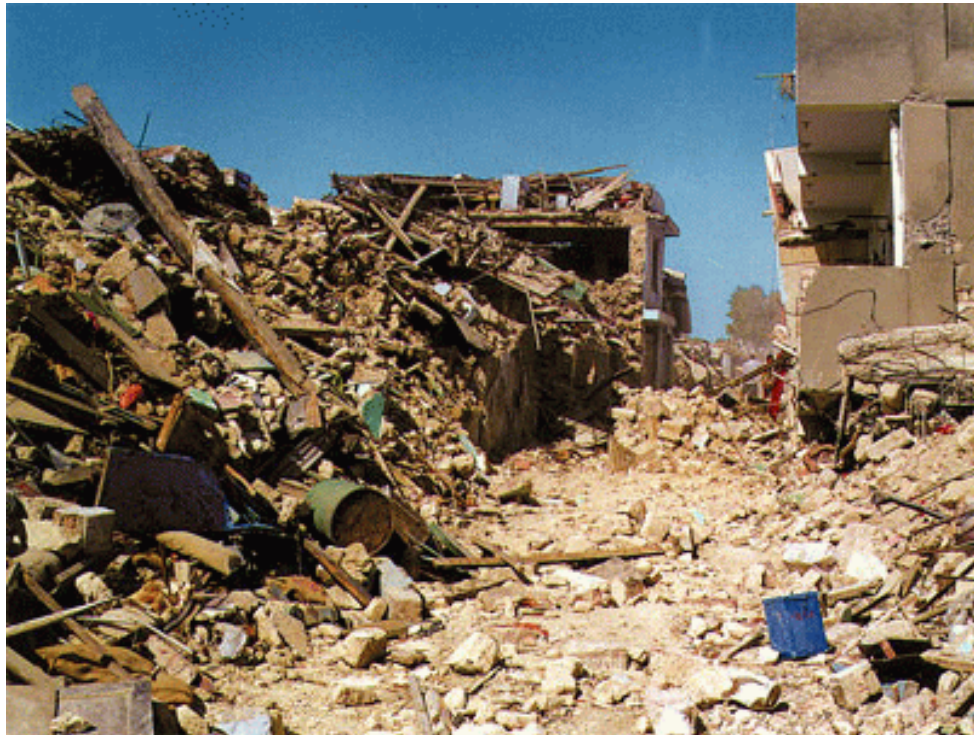
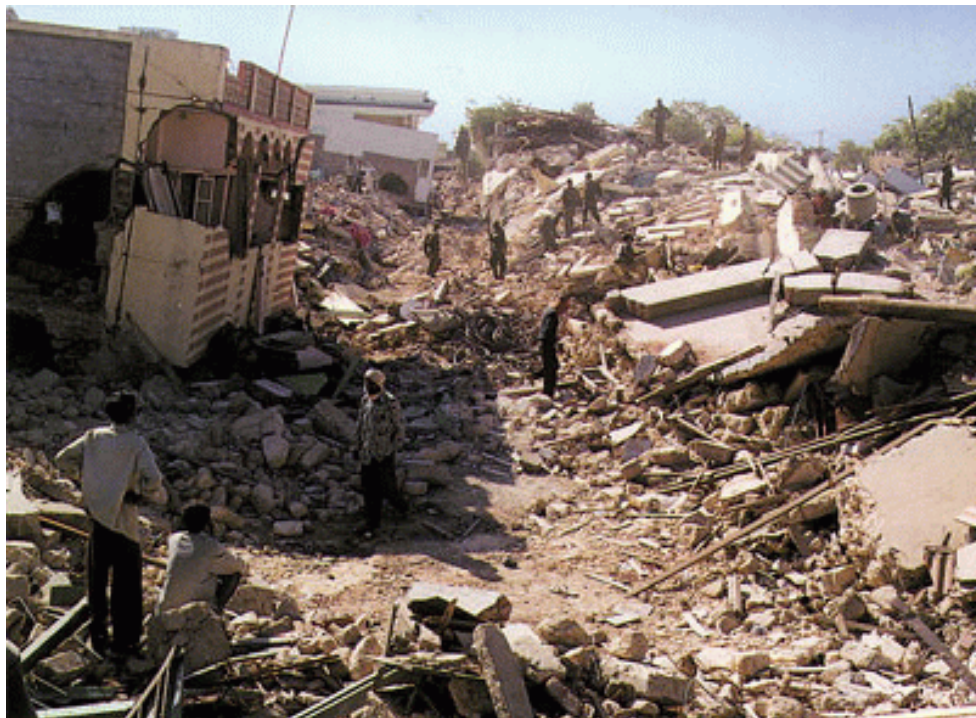
Figures 2 and 3: Photos of damage from the Bhuj Earthquake.

Figures 2 and 3 are photos showing damage from the Bhuj earthquake.

According to the Gujarat Relief Engineering Advice Team, the building damage was caused by a combination of effects (Patel et al, 2001).

- Old decaying buildings predating modern construction practices.
- New buildings not being designed to Indian seismic building codes.
- Lack of knowledge, understanding, or training in the use of Indian seismic building codes by local engineers.
- Unawareness that Gujarat is a highly seismic region.
- Buildings erected without owners seeking proper engineering advice.
- Improper detailing of masonry and reinforced structures.
- Poor materials, construction, and workmanship used, particularly in commercial buildings.
- Alterations and extensions being carried out without proper regard for effects on structure during and earthquake.
- Buildings having poor quality foundations or foundations built on poor soils.
- Little or no regulatory authority administering or policing the seismic building codes.

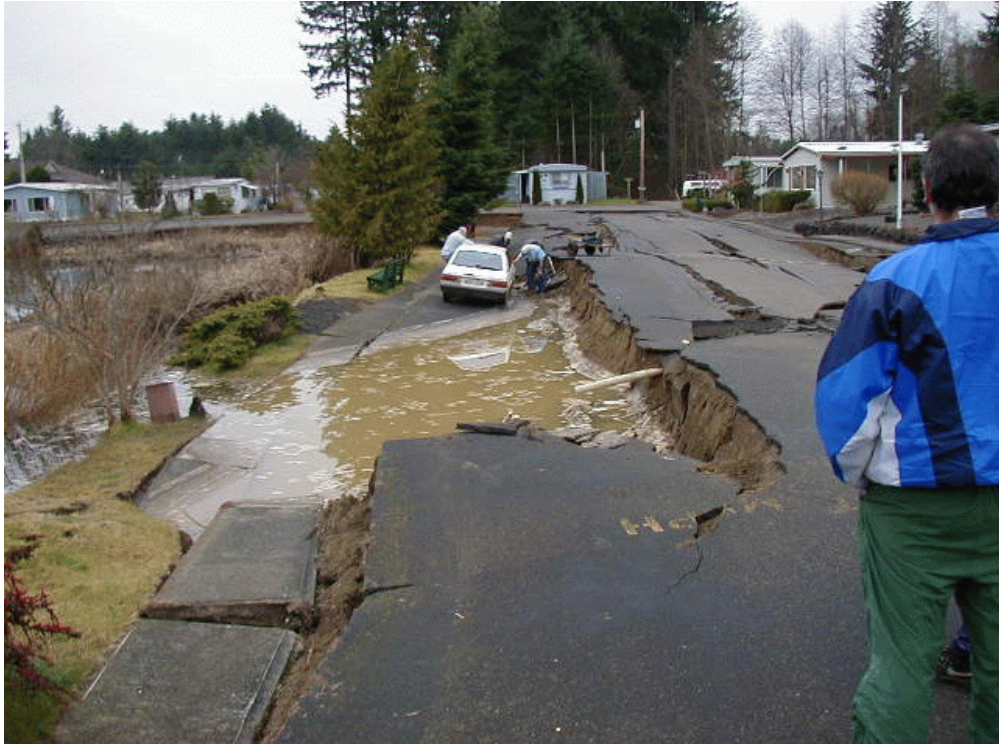
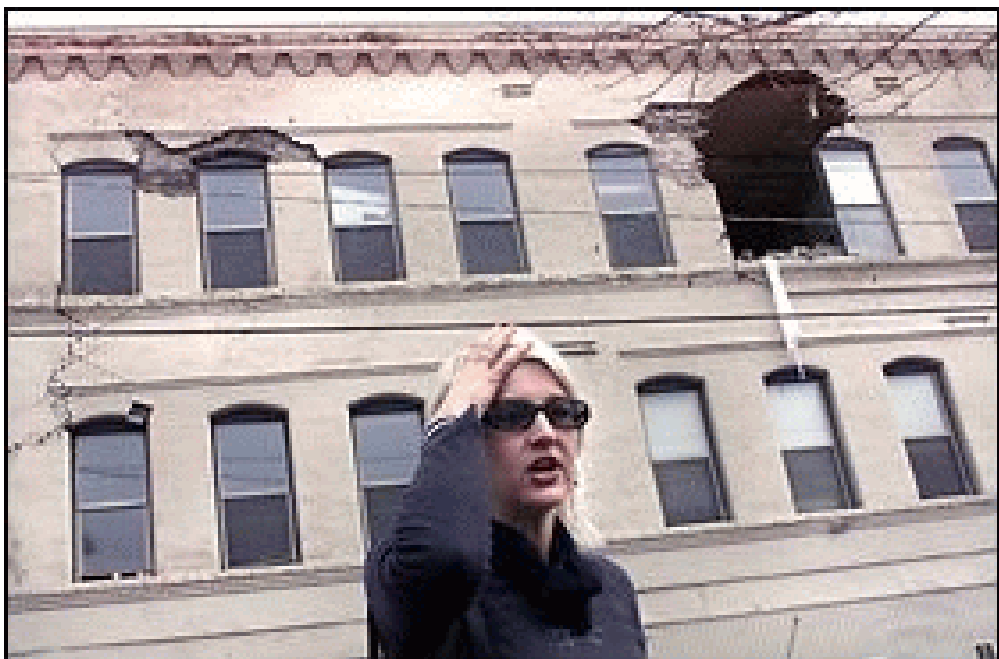
Figures 5 and 6: Photos of damage from the Nisqually Earthquake.

Figures 5 and 6 are photos showing damage from the Nisqually earthquake.

The reasons for the very small loss of life from the Nisqually earthquake can be attributed to several factors. First, from a geological perspective, the hypocentral depth of the Nisqually earthquake was 52 km below the surface and was more than twice as deep as the Bhuj earthquake. In the Nisqually earthquake, there was a large expanse of “very strong” shaking, but no reports of “severe or violent shaking” even in those places nearest to the epicenter. Within the first week of the Nisqually earthquake, only a few aftershocks had been recorded, and the largest was a magnitude 3.4 event. It is common in earthquake devastated areas for moderately sized aftershocks to damage already weakened structures, so the lack of aftershocks must have been a mitigating factor in minimizing the total loss. (SCEC 2002)
