REAL-TIME AUTOMATED DAMAGE ESTIMATION USING INFORMATION TECHNOLOGY AND SPATIAL IMAGERY

Abstract

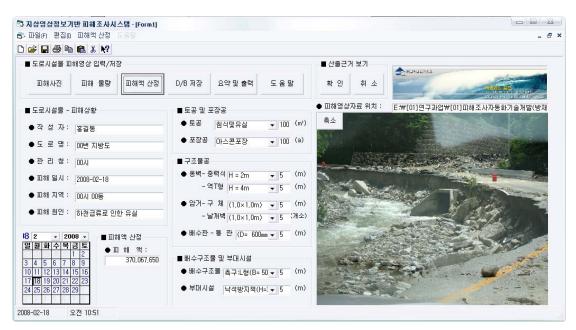
In this study, we developed software that could estimate amount of damage from stereo images and transmit damage information in real time to a web server. Figure 2 shows the software for estimation of amount of damage by public facilities, which programmed by Microsoft Visual Basic. Figure 3 is the real-time transmission software of damage information with photos and quantitative information based on C# program language.

Figure 2. Software for estimation and management of damage

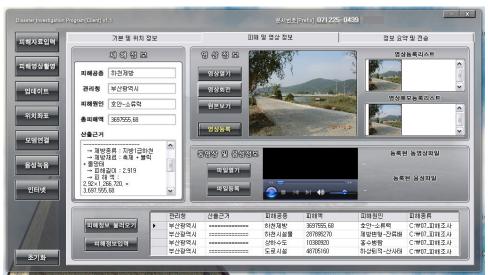
Figure 3. Software for real-time transmission of disaster damage
