BEHAVIOR BY SHAKING TABLE TEST FOR QUANTIFICATION OF COLLAPSE MARGIN OF STEEL HIGH-RISE BUILDINGS

ABSTRACT :

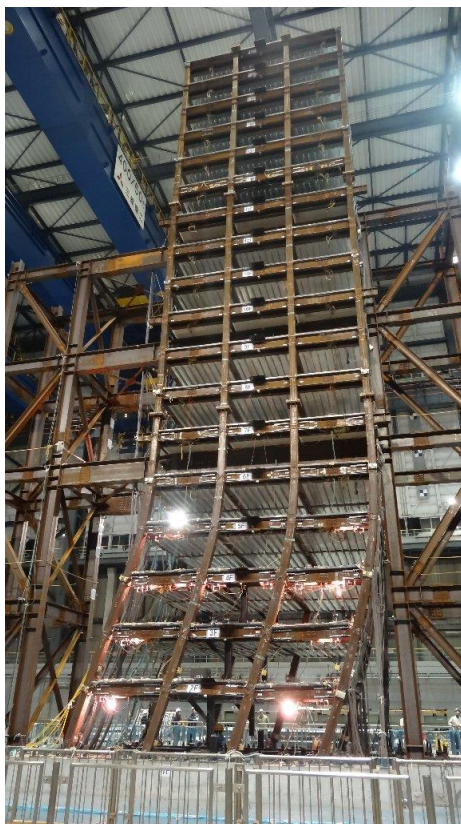
(a) Collapse mechanism

Photos of test specimen after collapse

When the shaking level is average, the test specimen had an enough margin to the collapse. And finally, when the shaking level is 3.8 times to average, the test specimen was damaged heavily with ductile fracture of beam ends and local buckling of columns and then collapsed by the loss of the gravity load support capacity of lower story columns.

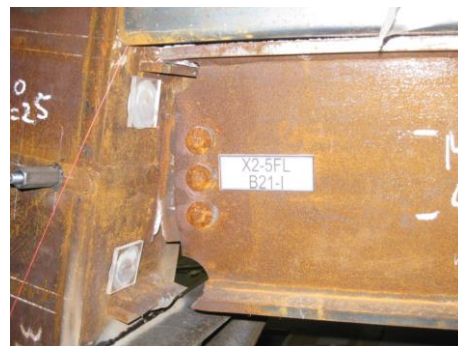
(b) fracture of beam end

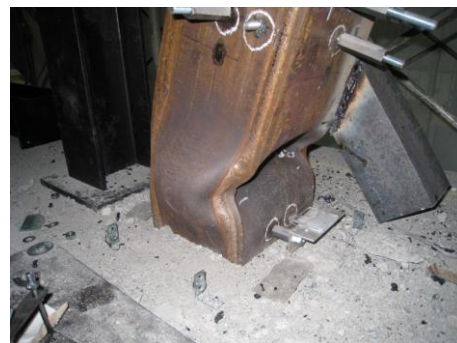
(c) local buckling of column
