Mustering exercise with 600 pax on board M/f Kronprins Frederik

Erling Ostergaard/H Ditlev Jorgensen
Scandlines Danmark A/S
Dampfaergevej 10
2100 Copenhagen
Denmark

Introduction

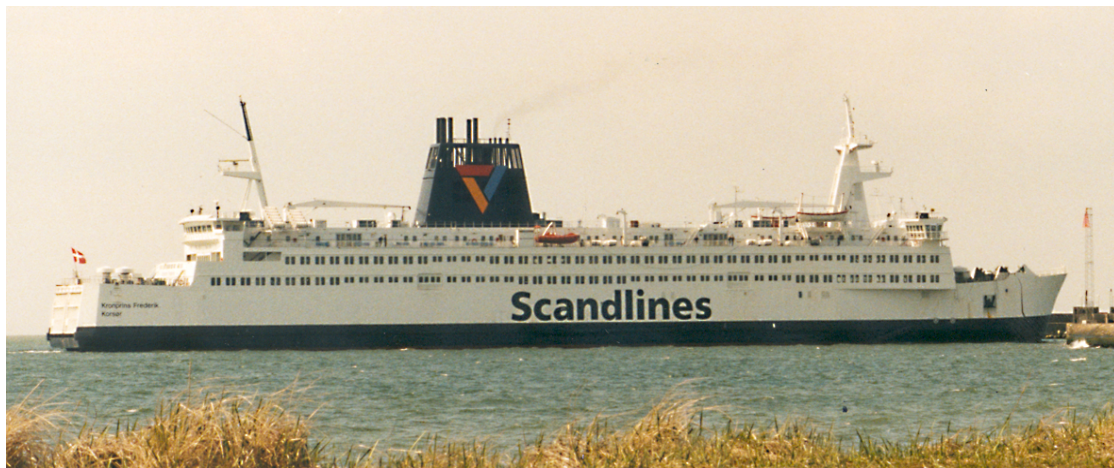
The paper describes the planning and simulated execution of a mustering exercise performed with about 600 passengers onboard the M/F Kronprins Frederik shown below at sea under the MEPdesign project (Mustering and Evacuation of Passengers).
