DAM SAFETY AND DEFORMATION MONITORING

(A STUDY ON OYMAPINAR DAM)

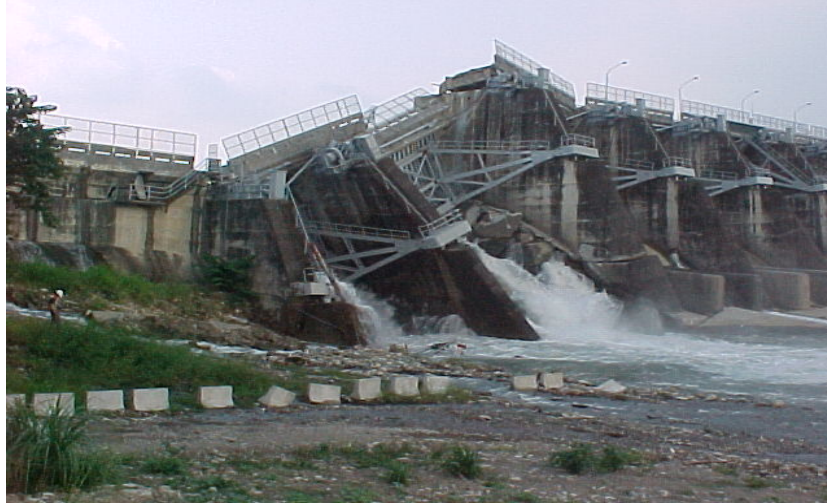
Figure 1. Taiwan Shih-Kang dam accident in a view (Dams4, 1999)

Dam and the large engineering structures, etc., continuously or periodically according to the structure function of the temperature climate change, water mass and body weight, water power, traffic load and the moving of ground such as the various factors under the influence will remain. These factors negatively affect the structure and environment change in the structure to occur. These changes are generally referred to as the deformation. In most cases, this deformation of the structure and function of the static structure is a great danger, but can be turned into disasters occurring large deformation. Above many different factors under the influence of are arise from a structure to determine the causes of movements and to measure the "Control of measurement" is called (Figure1), (Gülal E., 2002 ve Dams4, 1999).
