Geomorphic Characterization of Bulakan, Bulacan and its Implications to the Proposed Land Use Development

Abstract— Implications to land-use development have been rapidly increasing as the cities in the country have been subjected to continuous urbanization. The municipality of Bulakan, Bulacan is one of those cities that has been continuously being eyed for different development programs. Bulakan is characterized as a floodplain in the north and a coastal plain in the south. Geomorphological characterization is done to delineate a geomorphological map of the area through QGIS v3.4 and ArcMap v10.8 to support and discuss through correlation the possible occurrences of geohazards such as flood and land subsidence in the study area. The results of the correlation showed that the municipality is at high risk in flooding and medium to high to medium risk in land subsidence if urbanization continues. Mitigating procedures such as regular monitoring, installing adequate drainages, and preventing construction of buildings in the high risks area are suggested. The research may be used in preparation for future planning and development of Bulakan, Bulacan as well as in the other areas with

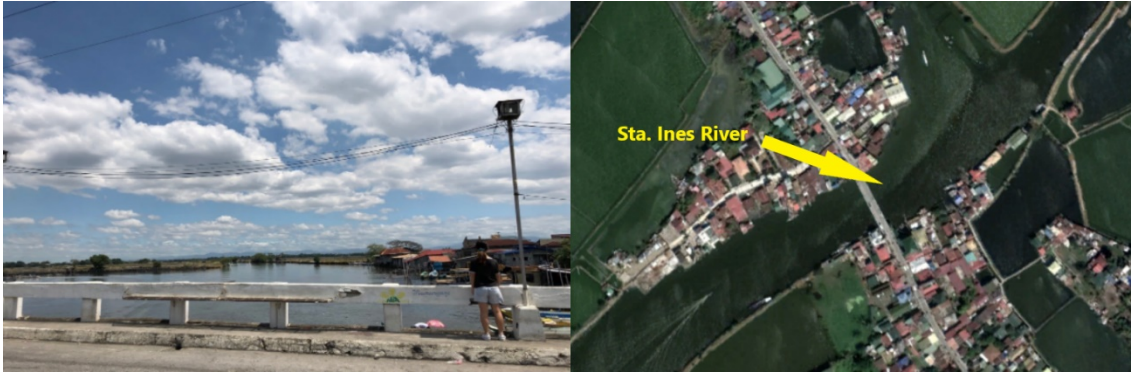
Figure 8. An actual picture and satellite image via Google Earth of Sta. Ines River traversing the whole municipality of Bulakan, Bulacan with coordinates: 14°46'5.28"N, 120°53'45.03"E

Meycauayan River has two major tributaries upstream: Bulacan River and Bambang River. The Bambang River is situated in the coastal area in the southern part of Bulakan; while the Bulacan River is in the eastern part of Bulakan. Other river channels in the area include the Guiguinto River and Balagtas River that are situated in the northern part of Bulakan; Matimbo River, Taliptip River, and Capiz River on the western part; and Sta. Ines River and Alipit River on the central part.

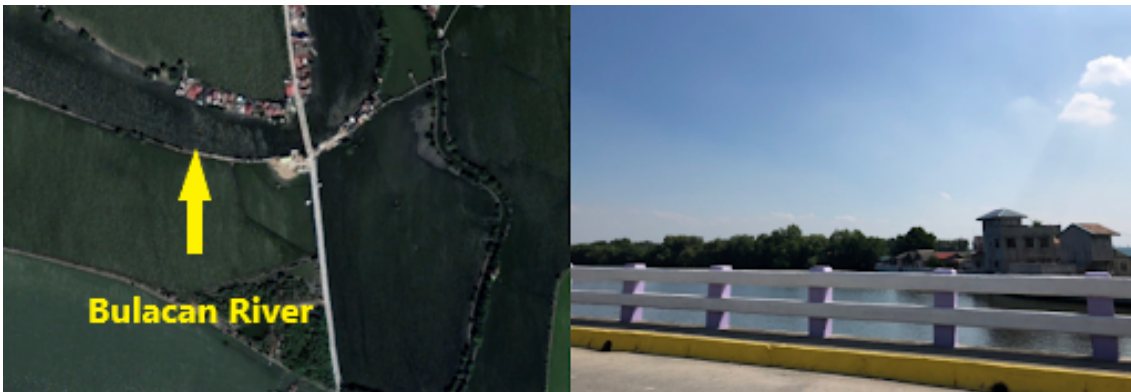
Figure 9. An actual picture and satellite image via Google Earth of Bulacan River traversing the Municipality of Bulakan to the Municipality of Obando with coordinates: 14°45'8.77"N, 120°54'36.38"E

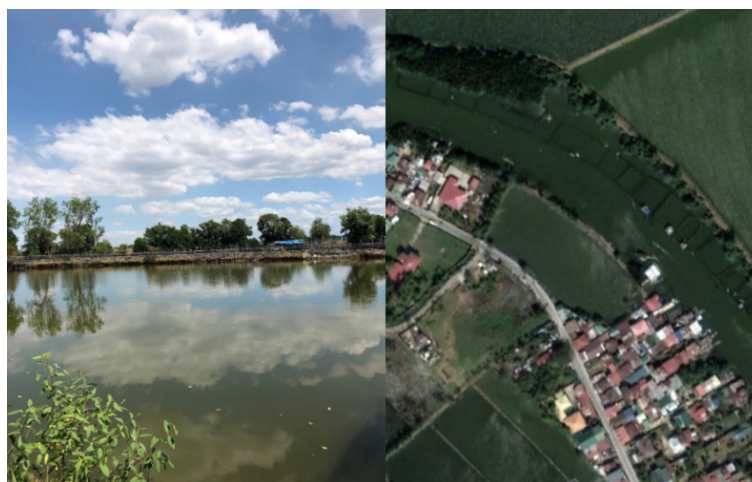
Figure 10. An actual picture and satellite image via Google Earth of the fishponds connected to the river with coordinates: 14°46'19.93"N, 120°53'35.06"E

Floodplains- both vegetated and non-vegetated- mostly make up the municipality of Bulakan. These are the areas most prone to flooding. Fishponds in the area are established on the non-vegetated floodplains.

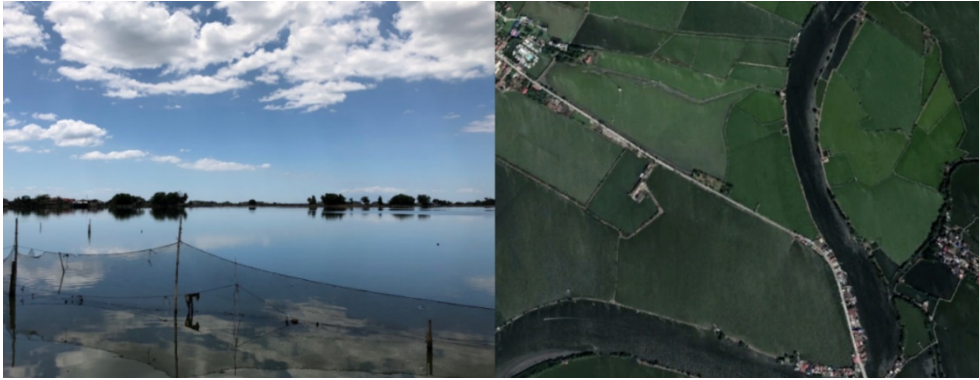
Figure 11. An actual picture and satellite image via Google Earth of the fishponds connected to the river with coordinates: 14°45'27.23"N, 120°54'26.20"E

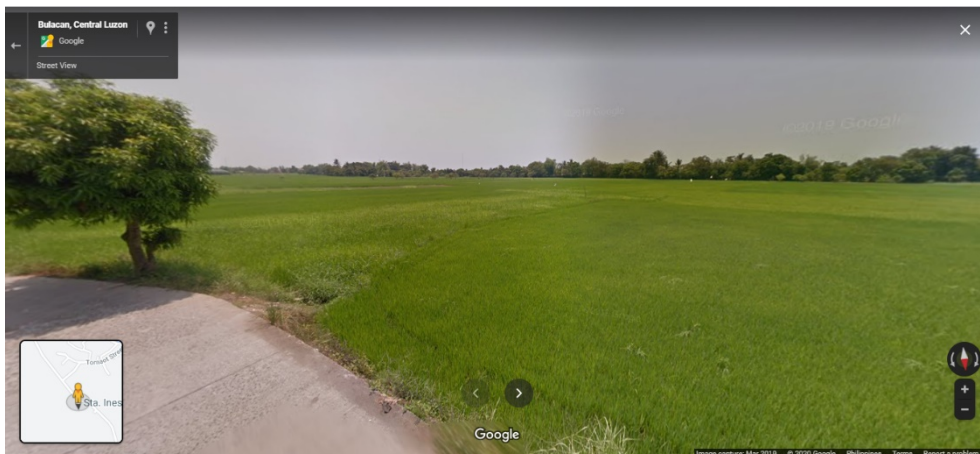
Figure 12. Vegetated Floodplain in the area observed through Google Street View with coordinates: 14°47'12.40"N, 120°52'28.93"E

Other floodplains seen in the area are agricultural areas where different types of crops are planted.

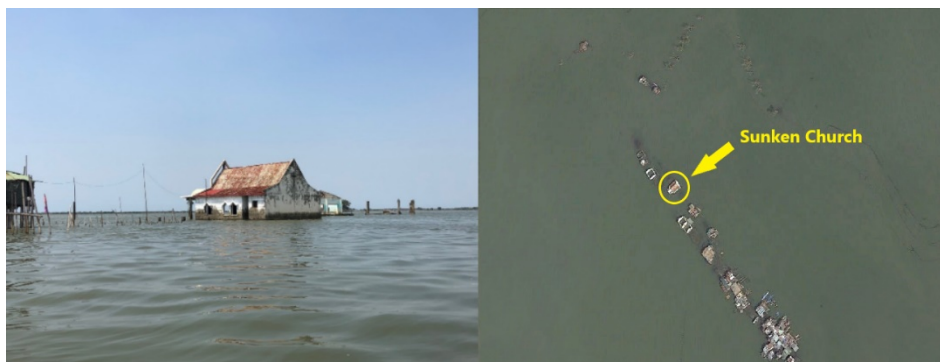
Figure 13. An actual picture and satellite image via Google Earth of the famous sunken church in Brgy. Taliptip, Bulakan, Bulacan with coordinates: 14°43'49.80"N, 120°53'18.10"E

The southernmost part of Bulakan is a coastal area. Sitio Pariahan in Brgy. Taliptip was once a residential land but is continuously sinking due to land subsidence; houses and other infrastructures in the area are now nearly fully submerged in water.

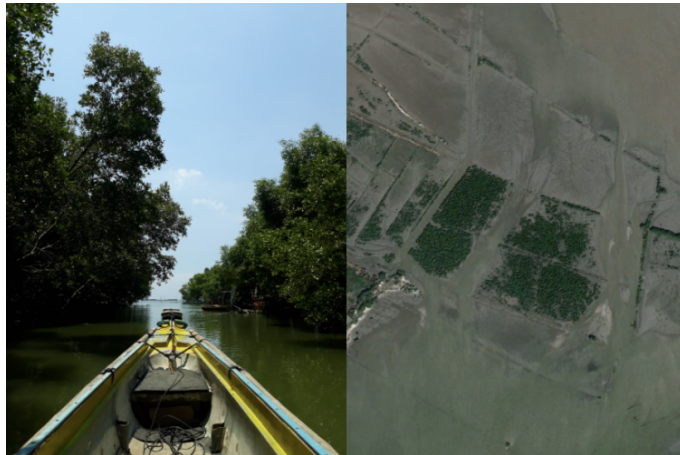
Figure 14. An actual picture and satellite image via Google Earth of the mangrove areas prominent in the study area with coordinates: 14°43'28.45"N, 120°52'36.86"E

Along the coastal area of Bulakan are tidal flats with vegetation which are mostly mangroves.

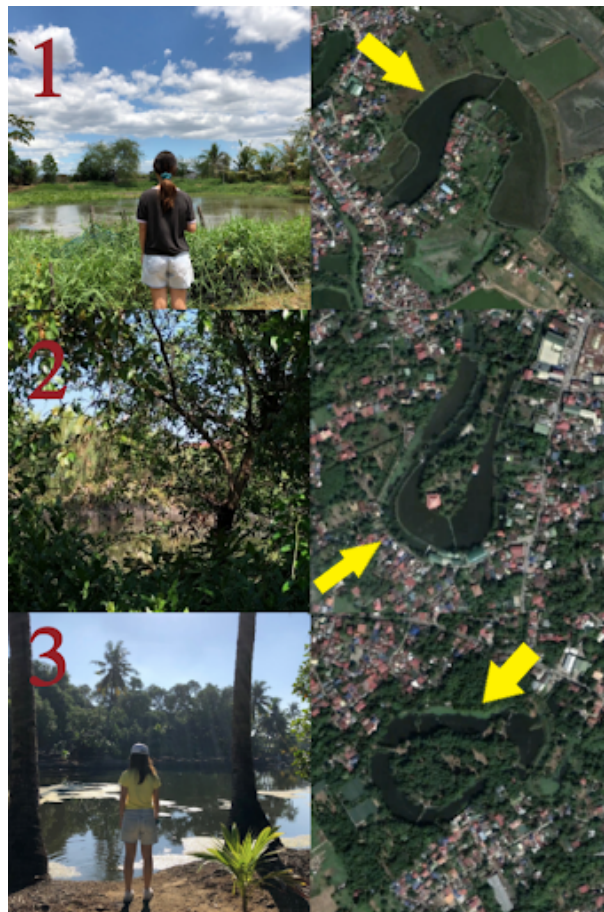
Figure 15. Actual pictures and satellite images via Google Earth of the oxbow lakes seen in the study area with coordinates: (1) 14°47'13.02"N, 120°53'12.57"E, (2) 14°47'26.07"N, 120°52'37.10"E, (3) 14°47'40.22"N, 120°52'21.51"E

Oxbow lakes seen in the area are formed from meanders of the Bagong Bayan River.

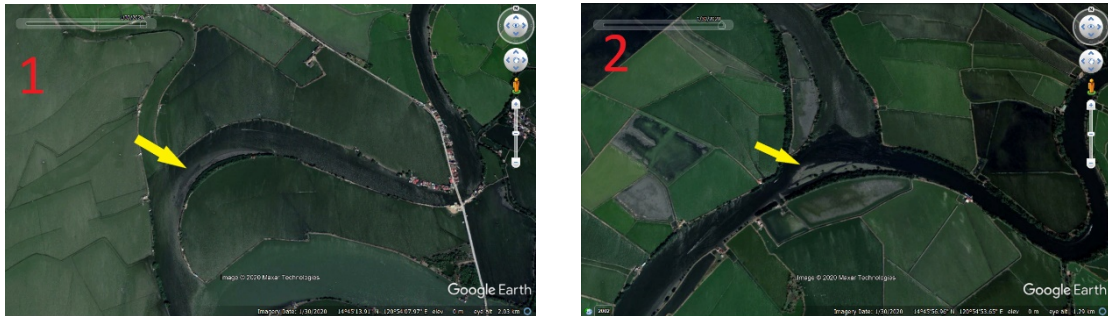
Figure 16. Point bars observed on Google Earth with coordinates: (1) 14°45'12.35"N, 120°53'57.89"E, (2) 14°45'56.31"N, 120°54'52.68"E

Point Bars were seen in the area through satellite images. These geomorphological units have accumulated on the inside bend of the Bulacan River. Vegetated bars are also observed in the area.

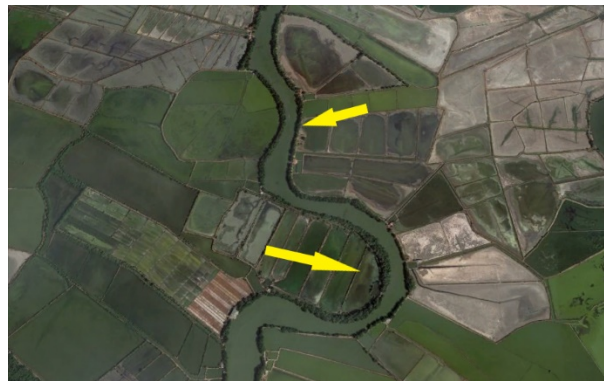
Figure 17. Levees along Capiz River

Levees are natural or artificial embankment or dike, usually parallel to the course of the river. Levees help stabilize river flow, preventing flooding and erosion on its adjacent areas.

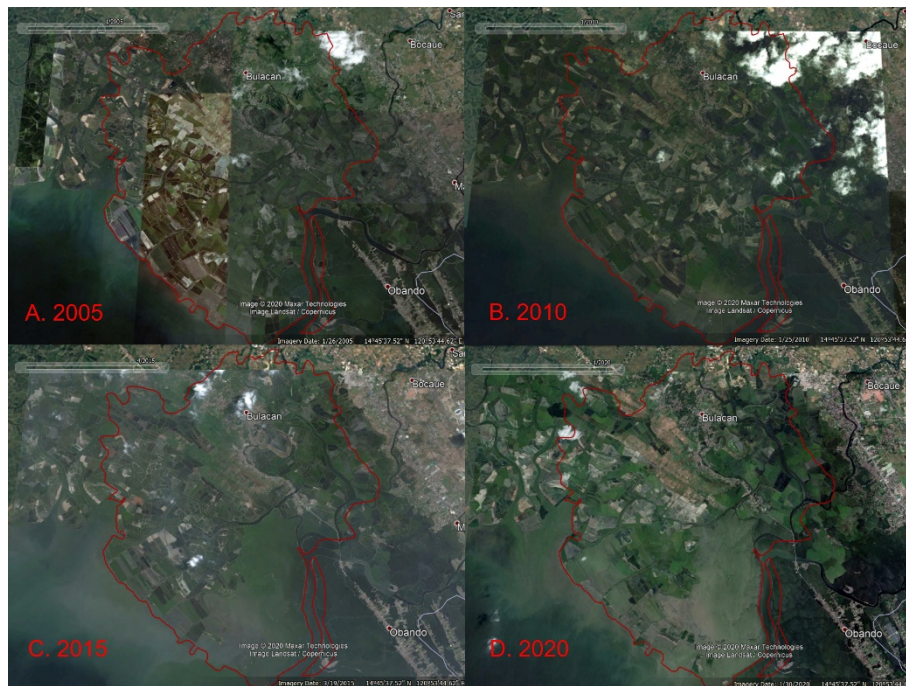
Figure 21. Time-series of satellite images of the study area showing proof of land subsidence

The study of Siringan and Rodolfo (2003) showed the subsidence rates in Pampanga Delta from well data and re-surveyed old benchmarks by DPWH, and the history of the repeated highway rising in response to enhanced flooding and tidal incursion. Another study by Rodolfo & Siringan (2006) mentioned that the Pampanga Delta is subsiding a cumulative >100 cm or a rate of 3-9 cm/yr. The municipality of Bulakan, which is a part of the Pampanga Delta, is under the same circumstances. The historical imagery of satellite images in *Figure 21* shows that Bulakan has subsided rapidly in the span of 15 years.

With this, it can be seen that the geomorphological units most affected by land subsidence are the coastal areas and non-vegetated floodplains along Manila Bay. Brgy,

Talipitip, which falls under the coastal area, suffers the most land subsidence in the area. Non-vegetated floodplains are also affected by land subsidence since fishponds are one of the main extractors of groundwater.

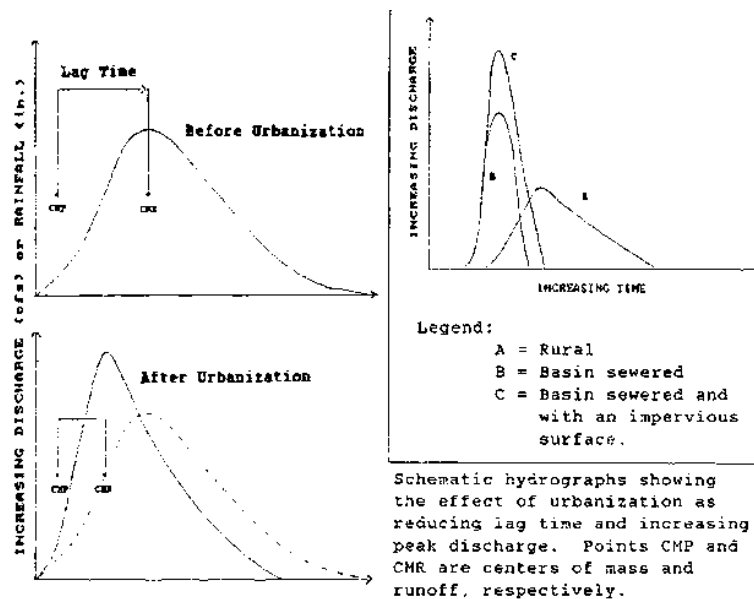
Figure 23. A diagram showing the correlation between runoff and discharge

Figure 23 shows that as the runoff time is decreased, the discharge rate increases. Artificial fills in the floodplain can reduce the flood channel capacity in the area and it will definitely increase the flood height.

Urbanization of the floodplain area will increase the amount and rate of surface runoff because there is hardly any surface area to absorb rainfall. Moreover, the rate of water flowing through channels and sewers will be fast.
